## **SAFETY INVESTIGATION REPORT**

**Malaysia Airlines Boeing B777-200ER (9M-MRO)  
08 March 2014**

**The Malaysian ICAO Annex 13 Safety Investigation Team for MH370**

Issued on 02 July 2018  
MH370/01/2018

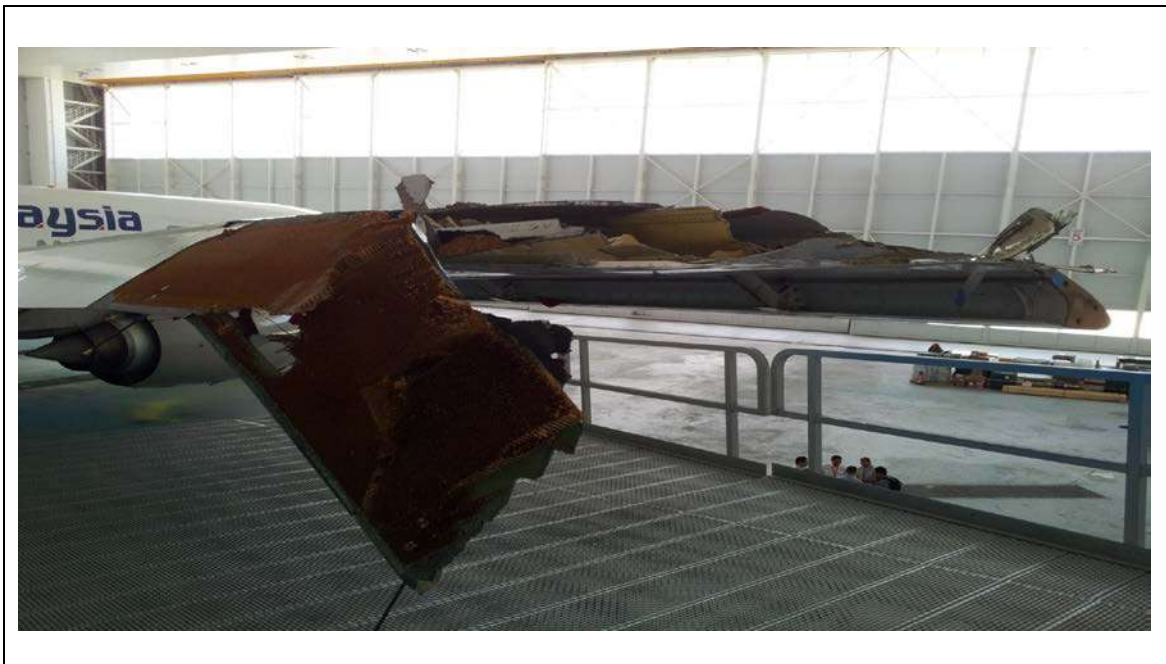
There was an entry in the Aircraft Log Book on 09 August 2012 that the aircraft right wing tip was damaged during taxiing at Pudong, Shanghai Airport. The aircraft collided with a China Eastern Airlines A340-600, registered B-6050. The right wing tip of 9M-MRO ran into the left horizontal stabilizer of B-6050. Part of the aircraft wing tip was ruptured and stuck at the left elevator of the B-6050. *Figures 1.6A and 1.6B (below) show the wing tip damages.*

*Figure 1.6A - Right Wing Tip Damage*

Boeing produced an Aircraft Survey Report reference WB175/W8134/LN404 on 15 August 2012 and the repair was carried out by Boeing Aircraft-On-Ground (AOG) Team at Pudong, Boeing Shanghai facility from 22 September to 03 October 2012. The Boeing repair scheme was approved under DCA Malaysia's Statement of Compliance (SOC) Reference Number SC/2012/081 issued on 03 September 2012. At the time of the incident, the recorded airframe hours were at 46,975:43 and landing cycles at 6,585.

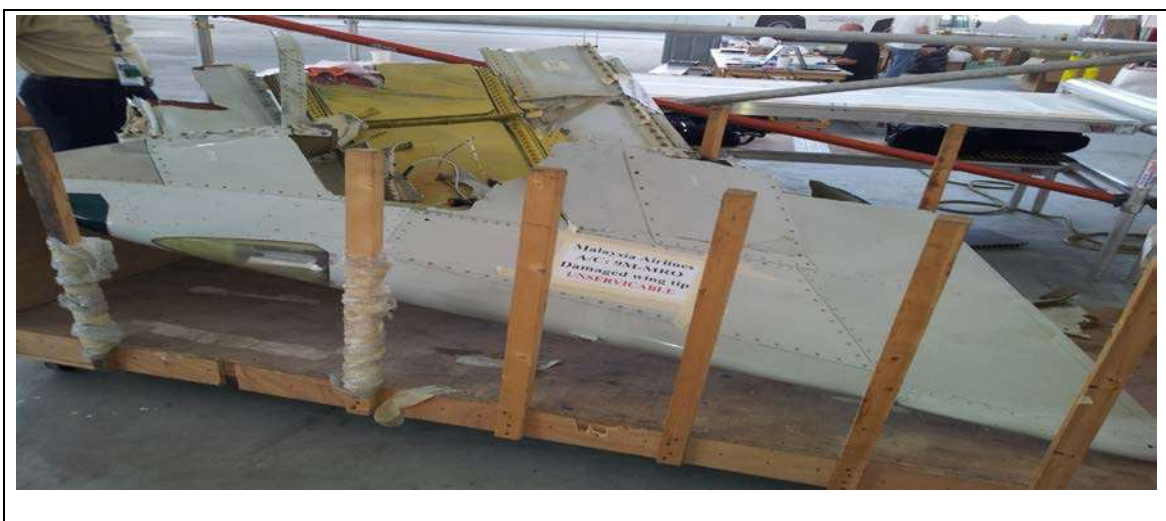
*Figure 1.6B - Damaged Wing Tip*

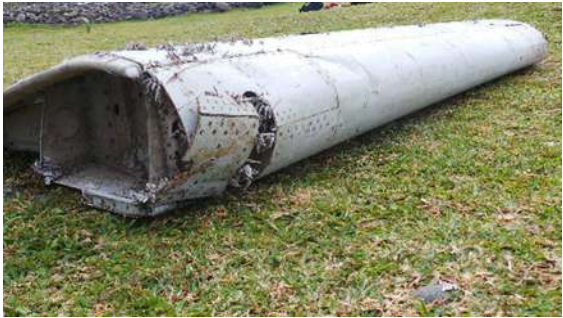
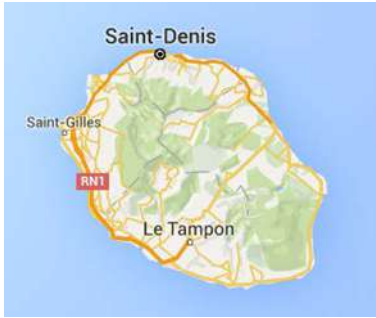
| Ref. | Date Found | Debris | Location | Remarks |
|---|---|---|---|---|
| Item 1 | 29 July 2015 | <p>Right Flaperon</p> | <p>Saint-Denis, Réunion Island</p> | <ul style="list-style-type: none"> <li>• <i>Confirmed</i> by French Judicial Authority belonging to MH370 on 03 September 2015</li> <li>• Refer to <i>Appendix 1.12A-1</i> and <i>Appendix 1.12A-2</i></li> </ul> |

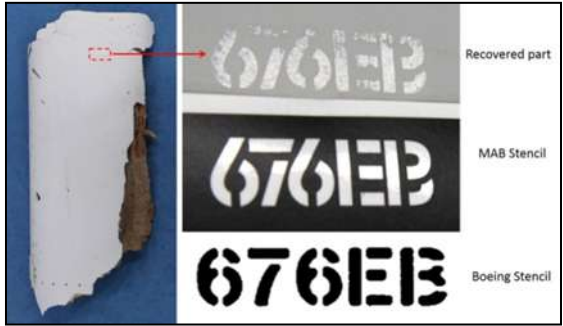
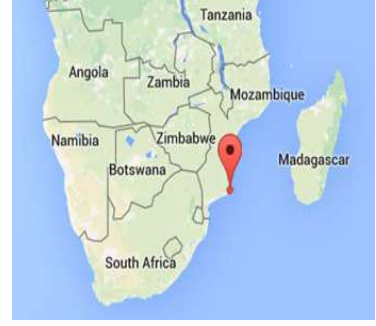
| Ref. | Date Found | Debris | Location | Remarks |
|---|---|---|---|---|
| Item 2 | 27 December 2015 | <p>Right Wing No. 7 Flap Support Fairing</p> | <p>Daghatane Beach, Mozambique</p> | <ul style="list-style-type: none"> <li>• Examination showed that part is <i>almost certain</i> from MH370</li> <li>• Refer to <i>Appendix 1.12B</i></li> </ul> |

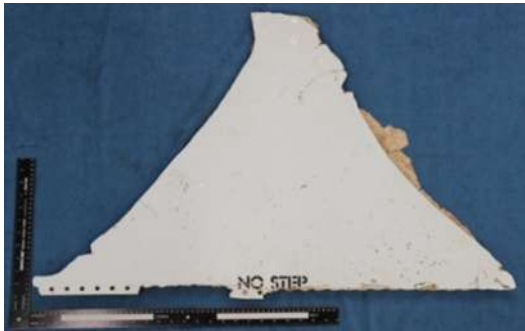
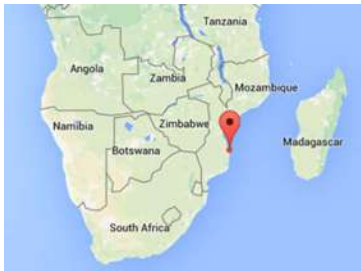
| Ref. | Date Found | Debris | Location | Remarks |
|---|---|---|---|---|
| Item 3 | 27 February 2016 | <p>Right Horizontal Stabiliser Panel</p> | <p>Valankulo, Paluma Sandbank, Mozambique</p> | <ul style="list-style-type: none"> <li>• Examination showed that part is <i>almost certain</i> from MH370</li> <li>• Refer to <i>Appendix 1.12B</i></li> </ul> |

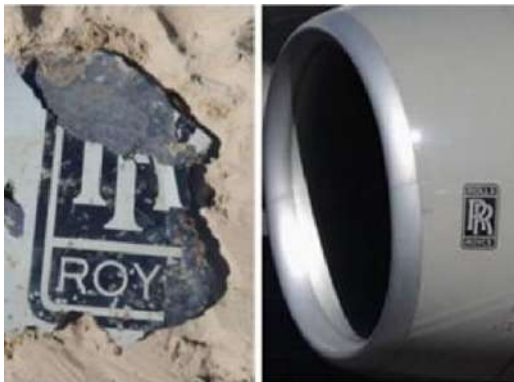
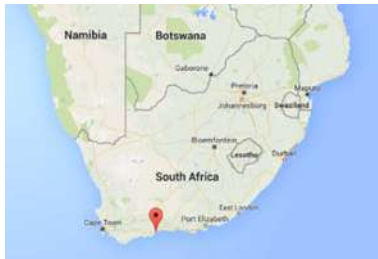
| Ref. | Date Found | Debris | Location | Remarks |
|---|---|---|---|---|
| Item 4 | 22 March 2016 | <p>Engine Nose Cowl</p> | <p>Mossel Bay, South Africa</p> | <ul style="list-style-type: none"> <li>• Examination showed that part is <i>almost certain</i> from MH370</li> <li>• Refer to <i>Appendix 1.12C</i></li> </ul> |

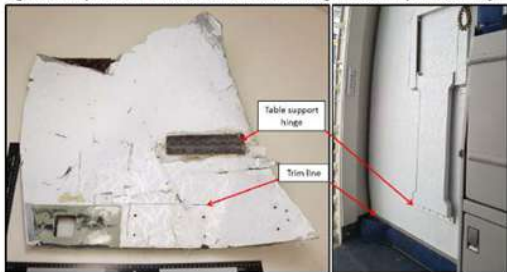
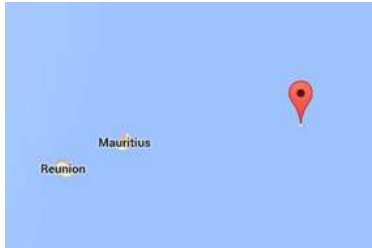
| Ref. | Date Found | Debris | Location | Remarks |
|---|---|---|---|---|
| Item 5 | 30 March 2016 | <p>Figure 2: Comparison of recovered item with MAB Boeing 777 Door R1 panel assembly</p> <p>Door R1 Stowage Closet</p> | <p>Rodrigues, Mauritius</p> | <ul style="list-style-type: none"> <li>• Examination showed that part is <i>almost certain</i> from MH370</li> <li>• Refer to <i>Appendix 1.12C</i></li> </ul> |

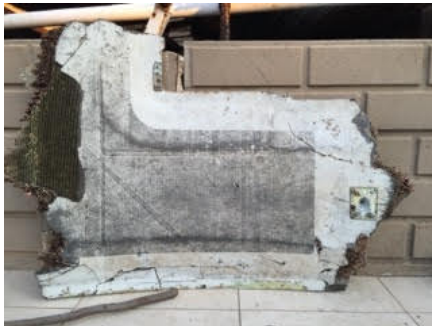
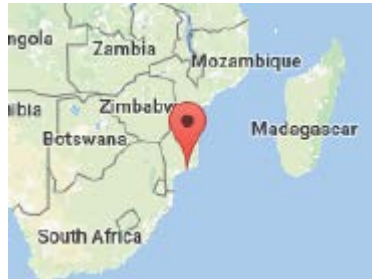
| Ref. | Date Found | Debris | Location | Remarks |
|---|---|---|---|---|
| Item 6 | 24 April 2016 | <p>Right Hand Engine Fan Cowling</p> | <p>South of Chidenguele,<br/>Mozambique</p> | <ul style="list-style-type: none"> <li>• Examination showed that part is <i>almost certain</i> from MH370</li> <li>• Refer to <i>Appendix 1.12D</i></li> </ul> |

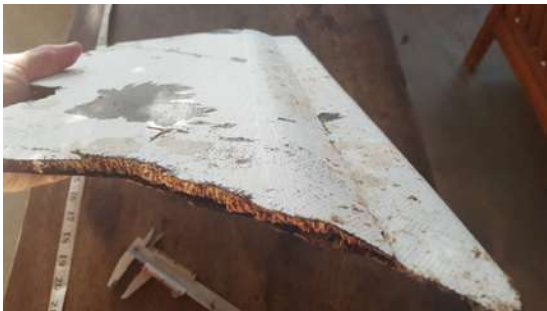
| Ref. | Date Found | Debris | Location | Remarks |
|---|---|---|---|---|
| Item 7 | 30 April 2016 | <p>Wing to Body Fairing</p> | <p>Anvil Bay, Chemucane,<br/>Mozambique</p> | <ul style="list-style-type: none"> <li>• Examination showed that part is <i>likely</i> from MH370</li> <li>• Refer to <i>Appendix 1.12E</i></li> </ul> |

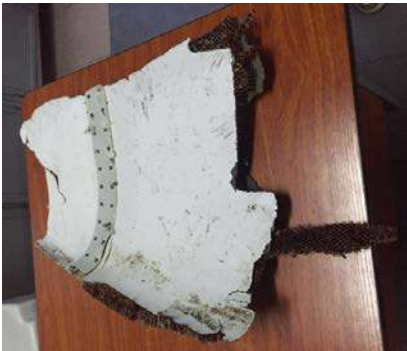
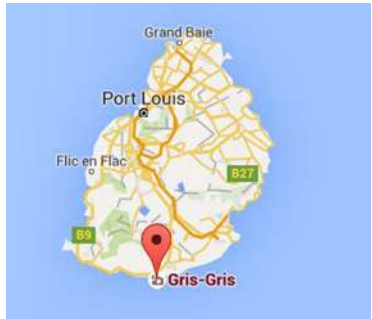
| Ref. | Date Found | Debris | Location | Remarks |
|---|---|---|---|---|
| Item 8 | 24 May 2016 | <p>No. 1 Flap Support Fairing Tail Cone</p> | <p>Gris Gris Beach,<br/>Mauritius</p> | <ul style="list-style-type: none"> <li>• Examination showed that part is <i>highly likely</i> from MH370</li> <li>• Refer to <i>Appendix 1.12F</i></li> </ul> |

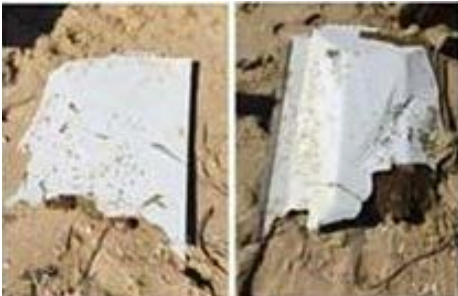
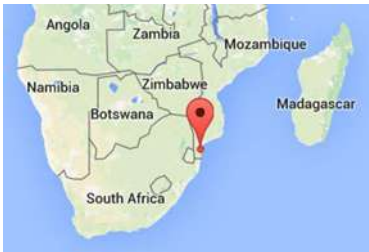
| Ref. | Date Found | Debris | Location | Remarks |
|---|---|---|---|---|
| Item 9 | 22 May 2016 | <p>Left Wing Trailing Edge Panel</p> | <p>Macenta Peninsular,<br/>Mozambique</p> | <ul style="list-style-type: none"> <li>• Examination showed that part is <i>highly likely</i> from MH370</li> <li>• Refer to <i>Appendix 1.12G</i></li> </ul> |

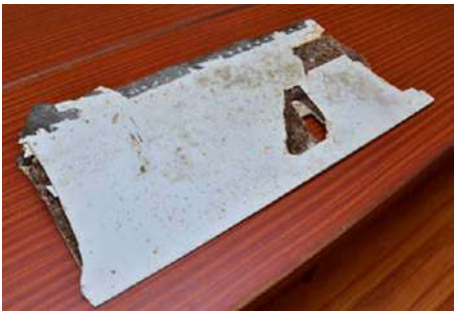
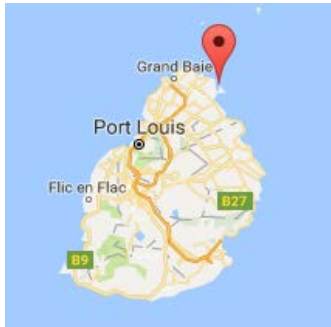
| Ref. | Date Found | Debris | Location | Remarks |
|---|---|---|---|---|
| Item 10 | 10 May 2016 | <p>Left Outboard Flap</p> | <p>Ilot Bernache, Mauritius</p> | <ul style="list-style-type: none"> <li>• This part is <i>confirmed</i> from MH370</li> <li>• Refer to <i>Appendix 1.12H</i></li> </ul> |

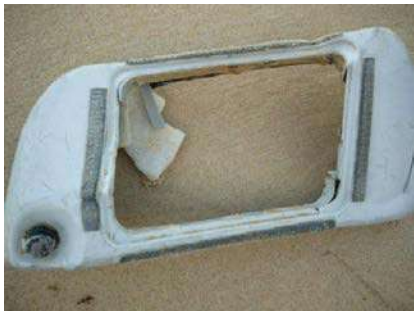
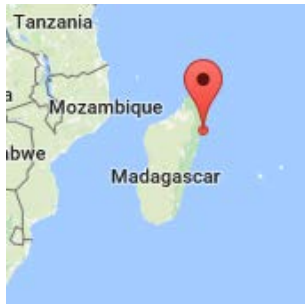
| Ref. | Date Found | Debris | Location | Remarks |
|---|---|---|---|---|
| Item 11 | 06 June 2016 | <p>Seat Back Trim Panel<br/>encasing IFE Monitor</p> | <p>Riake beach, Nosy<br/>Boraha Island,<br/>Madagascar</p> | <ul style="list-style-type: none"> <li>• Examination showed that part is <i>highly likely</i> from MH370</li> <li>• Refer to <i>Appendix 1.12I</i></li> </ul> |

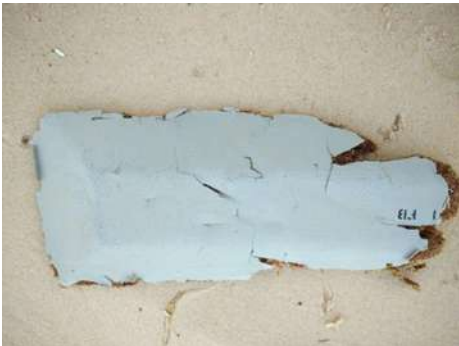
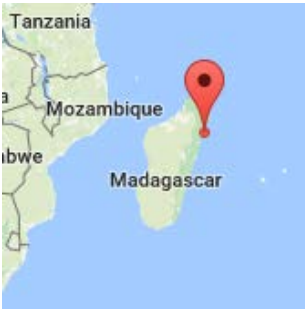
| Ref. | Date Found | Debris | Location | Remarks |
|---|---|---|---|---|
| Item 12 | 06 June 2016 | <p>Bottom panel on the Wing or<br/>Horizontal Stabilizer</p> | <p>Riake beach, Nosy<br/>Boraha Island,<br/>Madagascar</p> | <ul style="list-style-type: none"> <li>• Examination showed that part is <i>likely</i> from MH370</li> <li>• Refer to <i>Appendix 1.12J</i></li> </ul> |

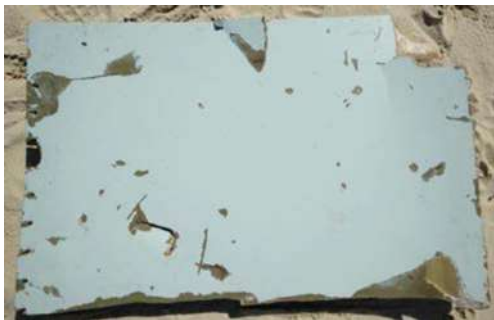
| Ref. | Date Found | Debris | Location | Remarks |
|---|---|---|---|---|
| Item 15 | 06 June 2016 | <p>Right Wing Trailing Edge Panel</p> | <p>Riake beach, Nosy<br/>Boraha Island,<br/>Madagascar</p> | <ul style="list-style-type: none"> <li>• Examination showed that part is <i>highly likely</i> from MH370</li> <li>• Refer to <i>Appendix 1.12G</i></li> </ul> |

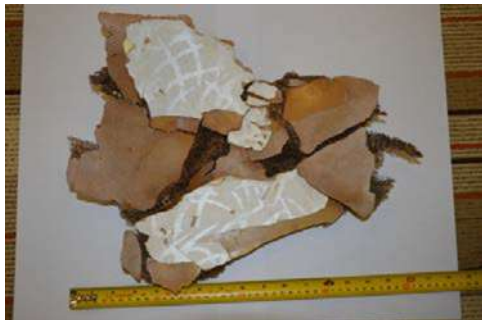
| Ref. | Date Found | Debris | Location | Remarks |
|---|---|---|---|---|
| Item 16 | 12 June 2016 | <p>Cabin Interior Panel</p> | <p>Antsiraka beach,<br/>Madagascar</p> | <ul style="list-style-type: none"> <li>• Examination showed that part is <i>almost certain</i> from MH370</li> <li>• Refer to <i>Appendix 1.12M</i></li> </ul> |

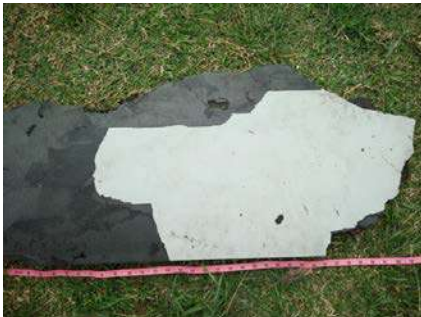
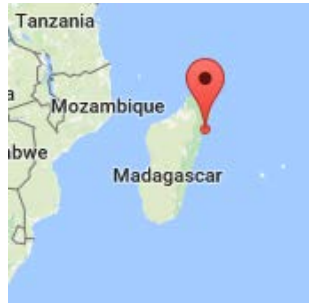
| Ref. | Date Found | Debris | Location | Remarks |
|---|---|---|---|---|
| Item 18 | 12 June 2016 | <p>Right Forward Nose Landing Gear Door</p> | <p>Antsiraka beach,<br/>Madagascar</p> | <ul style="list-style-type: none"> <li>• Examination showed that part is <i>highly likely</i> from MH370</li> <li>• Refer to <i>Appendix 1.12N</i></li> </ul> |

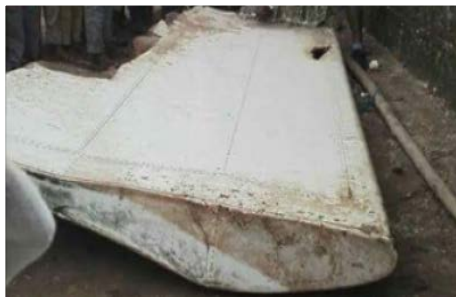
| Ref. | Date Found | Debris | Location | Remarks |
|---|---|---|---|---|
| Item 19 | 20 June 2016 | <p>Right Outboard Flap</p> | <p>Pemba Island,<br/>East of Tanzania</p> | <ul style="list-style-type: none"> <li>• The part is <i>confirmed</i> from MH370</li> <li>• Refer to <i>Appendix 1.12O</i></li> </ul> |

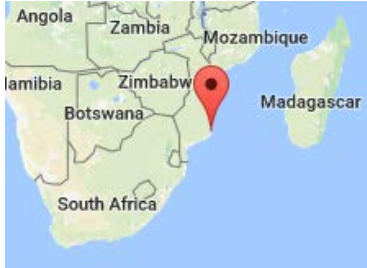
| Ref. | Date Found | Debris | Location | Remarks |
|---|---|---|---|---|
| Item 22 | 26 August 2016 | <p>Right Vertical Stabilizer Panel</p> | <p>Linga Linga beach<br/>Mozambique</p> | <ul style="list-style-type: none"> <li>• Examination showed that part is <i>almost certain</i> from MH370</li> <li>• Refer to <i>Appendix 1.12R</i></li> </ul> |

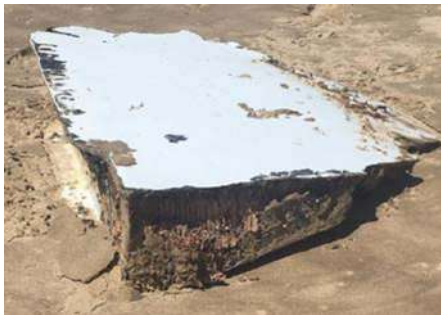
| Ref. | Date Found | Debris | Location | Remarks |
|---|---|---|---|---|
| Item 26 | 23 December 2016 | <p>Right Aileron</p> | <p>Nautilus Bay,<br/>South Africa</p> | <ul style="list-style-type: none"> <li>• Examination showed that part is <i>highly likely</i> from MH370</li> <li>• Refer to <i>Appendix 1.12V</i></li> </ul> |

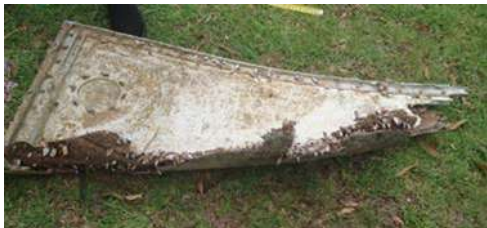
| Ref. | Date Found | Debris | Location | Remarks |
|---|---|---|---|---|
| Item 27 | 27 January 2017 | <p>Right Wing No. 7 Flap Support Fairing</p> | <p>Mpame Beach,<br/>South Africa</p> | <ul style="list-style-type: none"> <li>• Examination showed that part is <i>highly likely</i> from MH370</li> <li>• Refer to <i>Appendix 1.12W</i></li> </ul> |
