## **SAFETY INVESTIGATION REPORT**

**Malaysia Airlines Boeing B777-200ER (9M-MRO)  
08 March 2014**

**The Malaysian ICAO Annex 13 Safety Investigation Team for MH370**

Issued on 02 July 2018  
MH370/01/2018

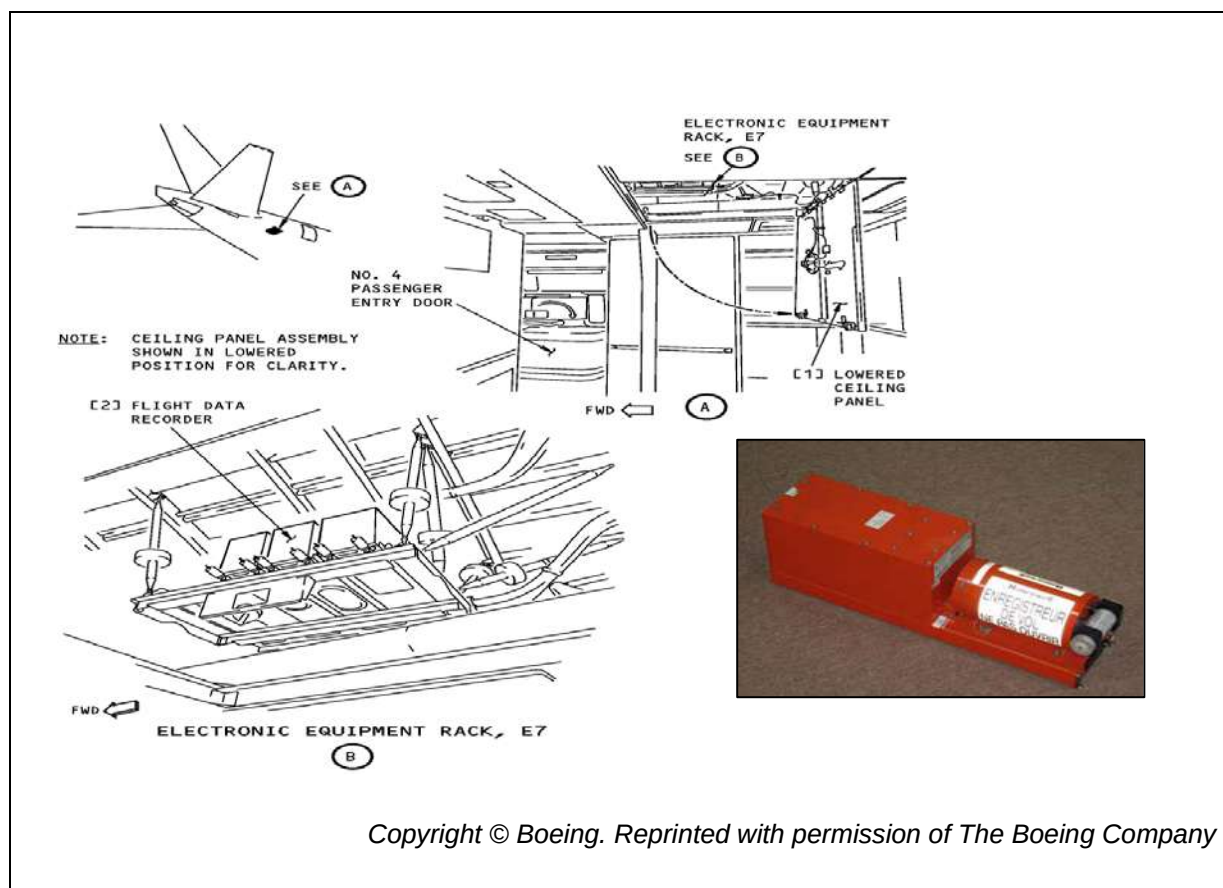
Figure 1.11A - Location of Solid State Flight Data Recorder

The solid state flight data recorder (SSFDR) is located in the Electronic Equipment rack, E7, which is in the aft cabin above the ceiling (Figure 1.11A [above]).

According to maintenance records, the solid state flight data recorder (SSFDR) Underwater Locator Beacon's (ULB) battery expired in December 2012. There is no evidence to suggest that the SSFDR ULB battery had been replaced before the expiry date. The SSCVR ULB battery however was replaced, as scheduled, with the next expiry in June 2014.

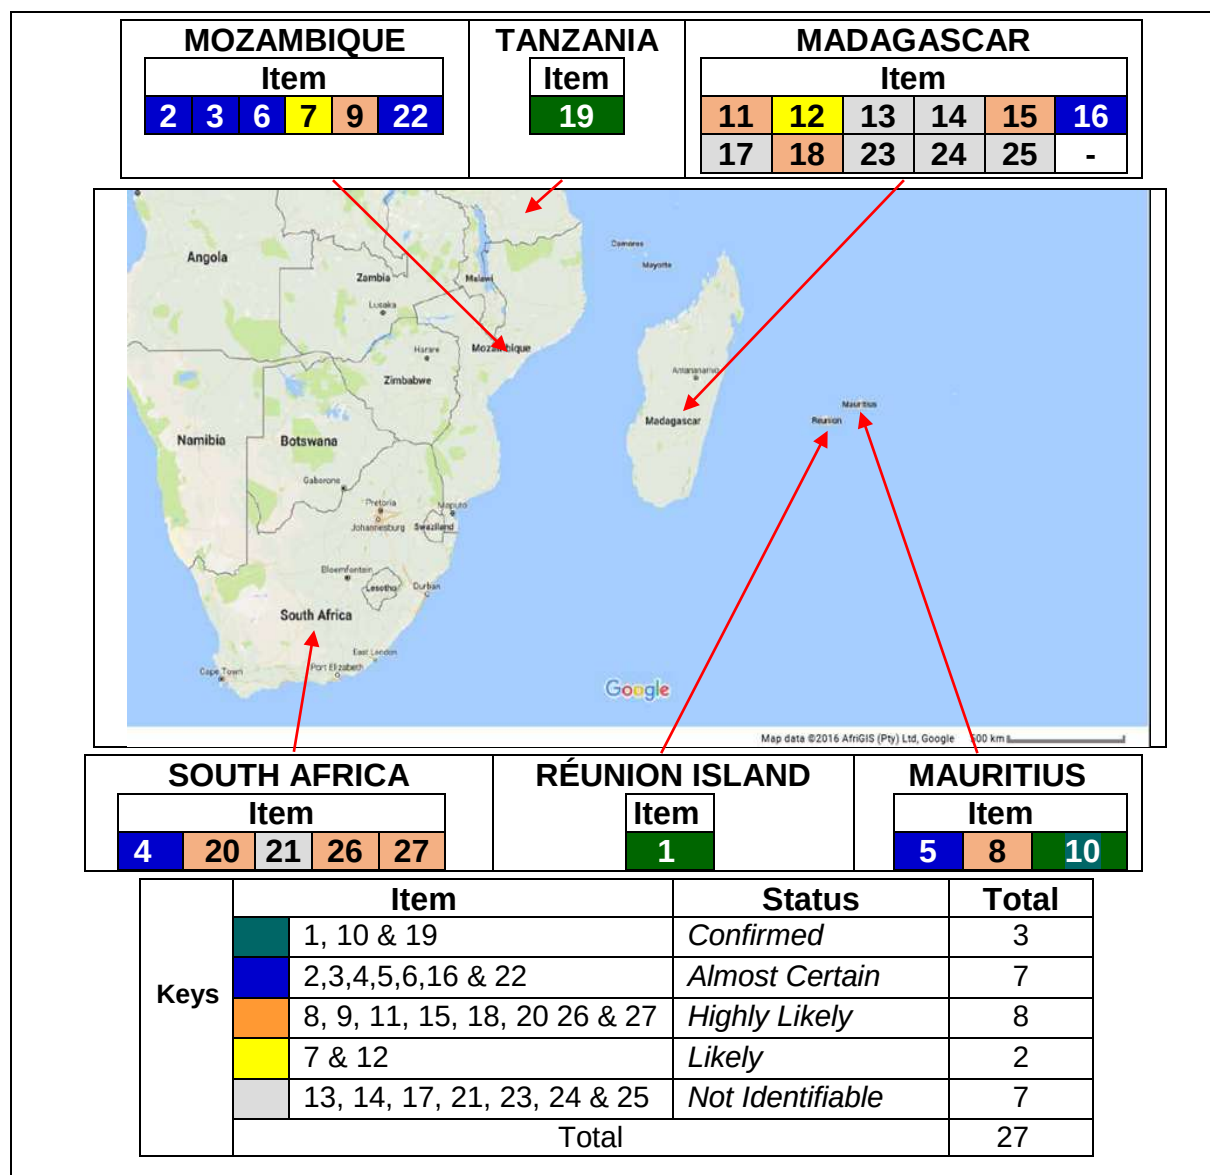
*Figure 1.12B - Locations and Status of Identification of the Debris*

No wreckage of the aircraft has been found after the completion of the search. However, several floating components and debris

confirmed/possibly from MH370 have been found as far as the south eastern coast of Africa. Refer to *Figure 1.12B* (below).

South Africa, Madagascar and Mauritius. *Figure 1.12B* (above) shows the distribution of the debris found in the above respective areas. *Table 1.12A* (below) provides a summary of the items of debris examined.

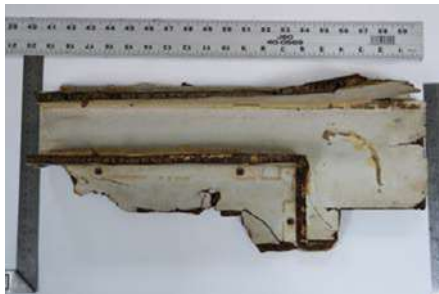
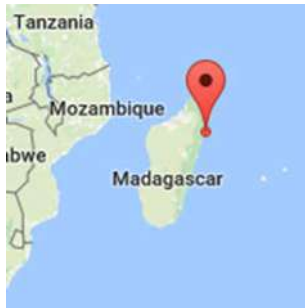
| Ref. | Date Found | Debris | Location | Remarks |
|---|---|---|---|---|
| Item 23 | October 2016 | <p>Unidentified Part</p> | <p>Riake beach, Nosy<br/>Boraha Island,<br/>Madagascar</p> | <ul style="list-style-type: none"> <li>• Not identifiable</li> <li>• Refer to <i>Appendix 1.12S</i></li> </ul> |

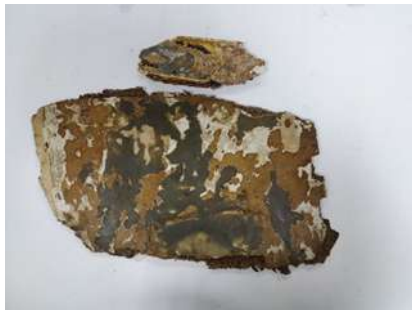
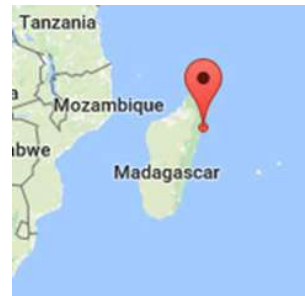
| Ref. | Date Found | Debris | Location | Remarks |
|---|---|---|---|---|
| Item 24 | February 2016 | <p>Unidentified Part</p> | <p>Saint Luce, Madagascar</p> | <ul style="list-style-type: none"> <li>• Not Identifiable</li> <li>• Refer to <i>Appendix 1.12T</i></li> </ul> |

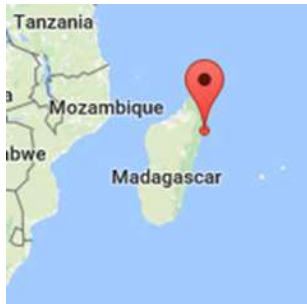
| Ref. | Date Found | Debris | Location | Remarks |
|---|---|---|---|---|
| Item 25 | July 2016 | <p>Unidentified Part</p> | <p>Riake beach, Nosy<br/>Boraha Island,<br/>Madagascar</p> | <ul style="list-style-type: none"> <li>• Not identifiable</li> <li>• Refer to <i>Appendix 1.12U</i></li> </ul> |

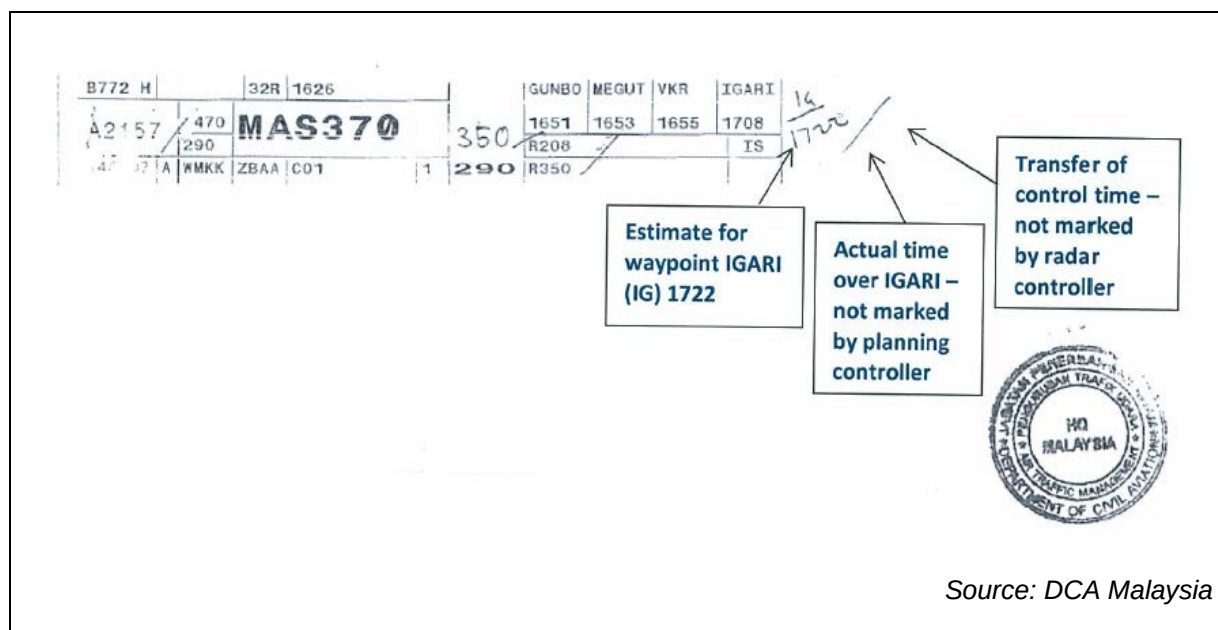
Figure 2.2G - Flight Progress Strip on MH370 from KL ACC

i) Two markings have been left out on the flight progress strip (FPS), *Figure 2.2G*, (below) of MH370:

- (1) The actual time (1721) when MH370 passed over IGARI - FPS' Estimate IG (abbreviation for IGARI) 1722, and
- (2) The transfer of control time (1719) on the FPS.

Since the two recordings on the Flight Progress Strip for MH370 were not marked by the Air Traffic Controllers (Planner and Radar) KL ACC did not have the record of the time of the last radio contact and the actual time of MH370 passing over waypoint IGARI.

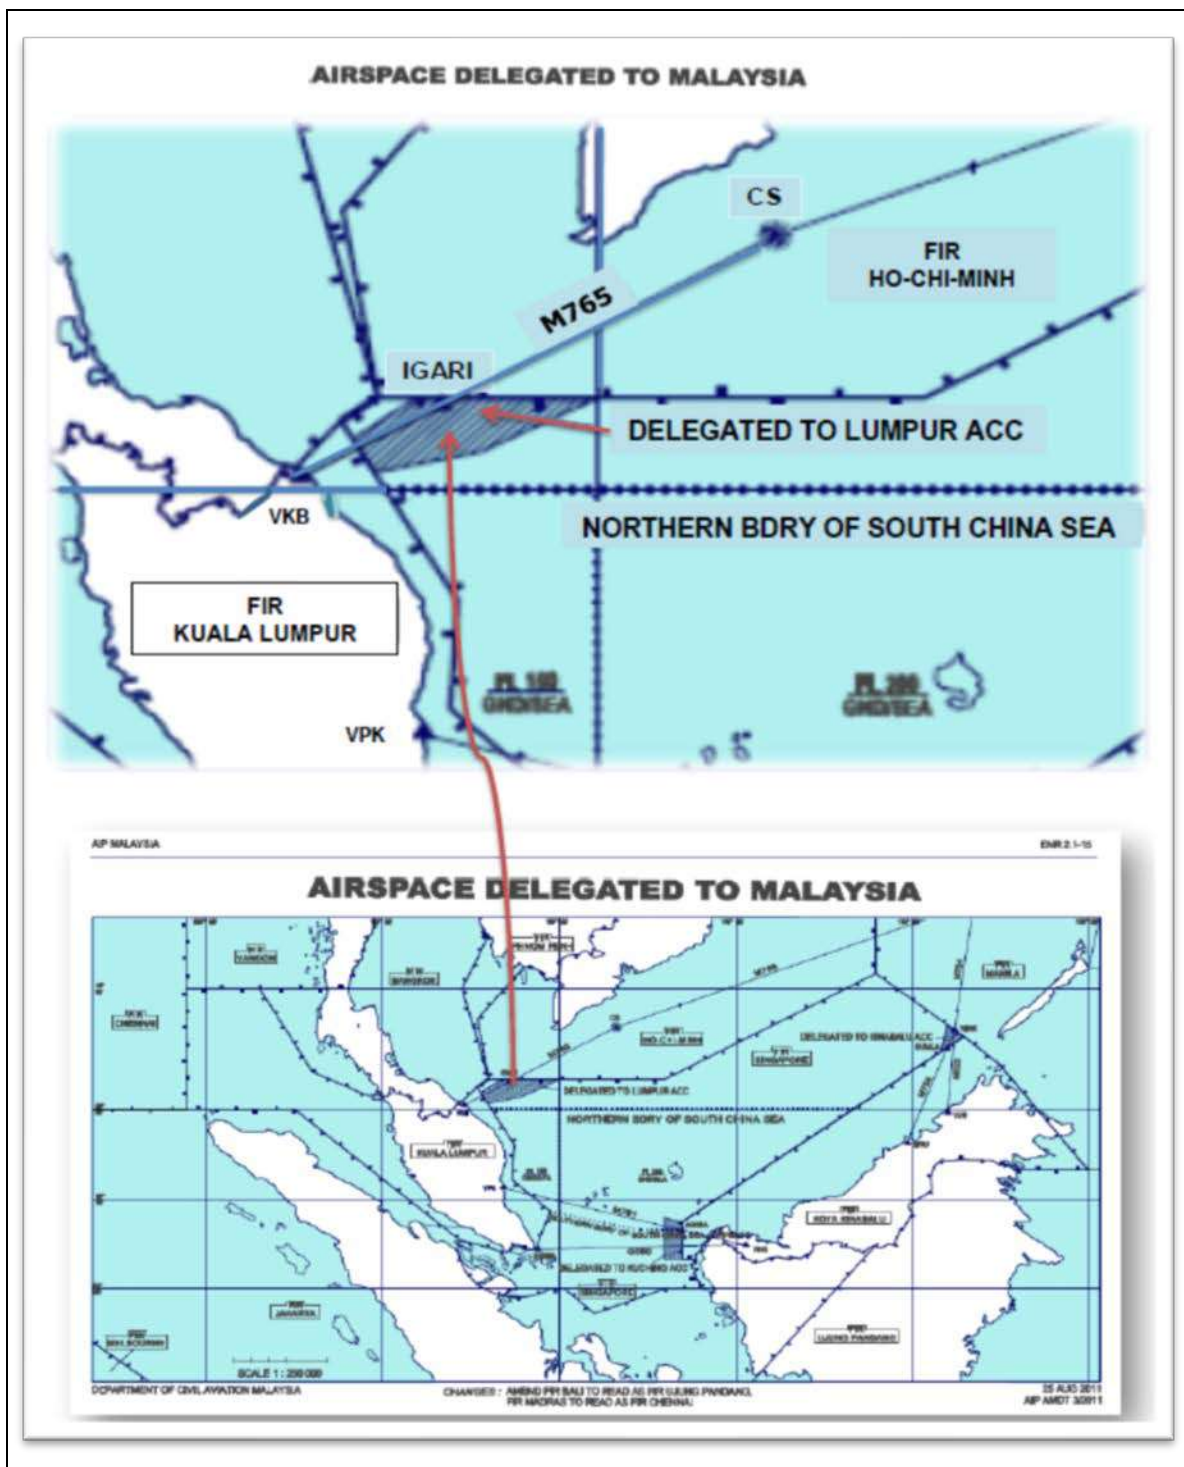
Figure 2.2N - Singapore Airspace delegated to Malaysia

- iv) Although Singapore ACC is responsible for the provision of SAR service within the delegated airspace, KL ACC did not inform Singapore ACC when MH370 was overdue. Nevertheless, Singapore RCC launched a search and rescue

aircraft to the search area after KL ARCC advised on the situation relating to MH370.

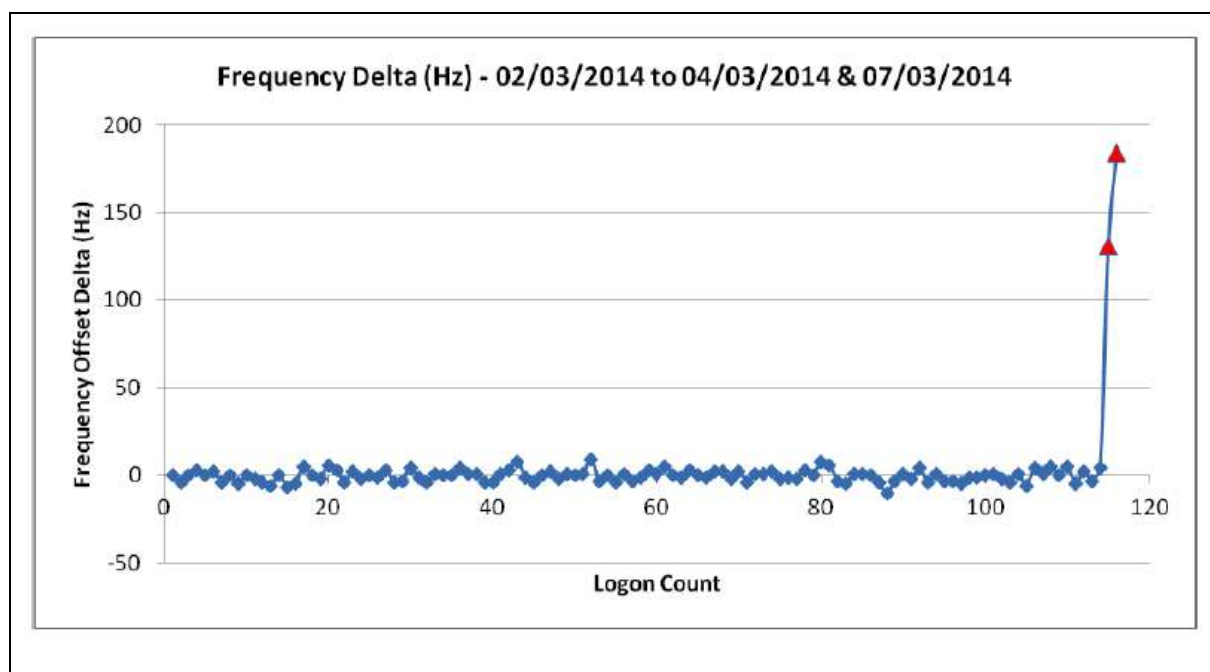
Figure 2.5A – Delta Frequencies between Pairs of Log-On Request and Log-On Acknowledge

- 1) During each of the two in-flight Log-Ons that occurred during flight MH370, the GES recorded abnormal frequency offsets for the SATCOM transmissions. This is in contrast with the 'normal' Log-On behaviour.

- 2) Table 1.9D in Section 1.9.5 shows the frequencies of these Log-On bursts, as measured at the GES, plus differences from assumed reference frequencies. The table also shows the very high delta frequencies between the respective Log-On Request and Log-On Acknowledge bursts.
- 3) The following graph (Figure 2.5A) shows the delta frequencies between pairs of Log-On Request and Log-On Acknowledge bursts for over one hundred Log-Ons of the SATCOM on-board 9M-MRO, up to and including the two during flight MH370. In every case prior to MH370 the delta frequencies were fairly small. Only the last two pairs of transmissions (the 1825 and 0019 Log-Ons) show significant deltas. Note that for ease of display, only the magnitude is shown for the two MH370 Log-On frequency deltas.

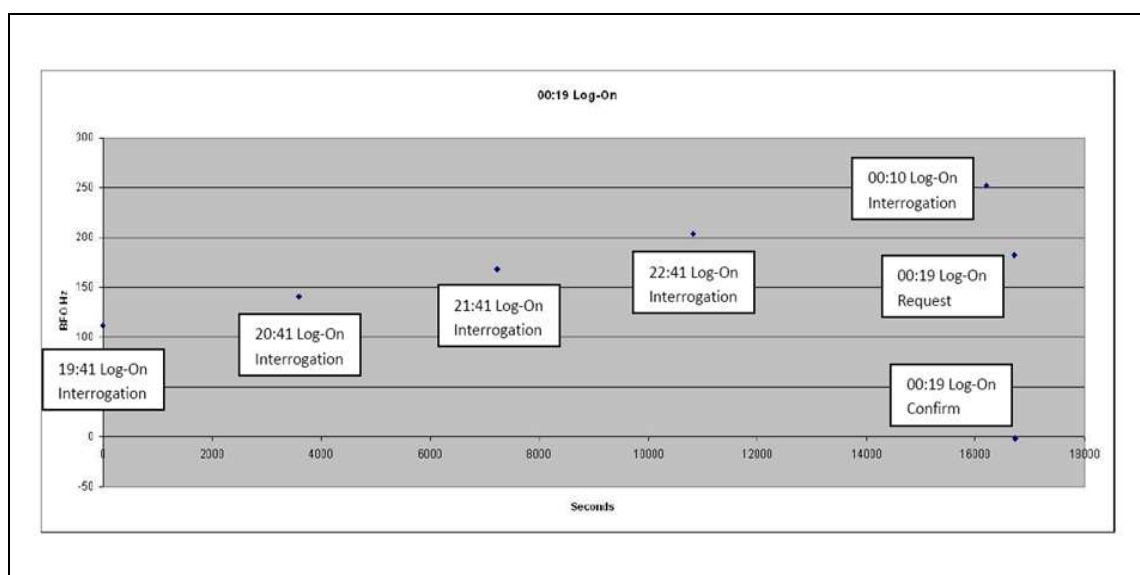
*Figure 2.5D - Log-On Interrogation Transmissions*

11) The plot (*Figure 2.5D*) below shows a series of MH370 Log-On Interrogation transmissions, which steadily rise in frequency (due to the satellite ephemeris). However, the 0019 Log-On Request and Log-On Acknowledge transmissions diverge from the steady state slope.

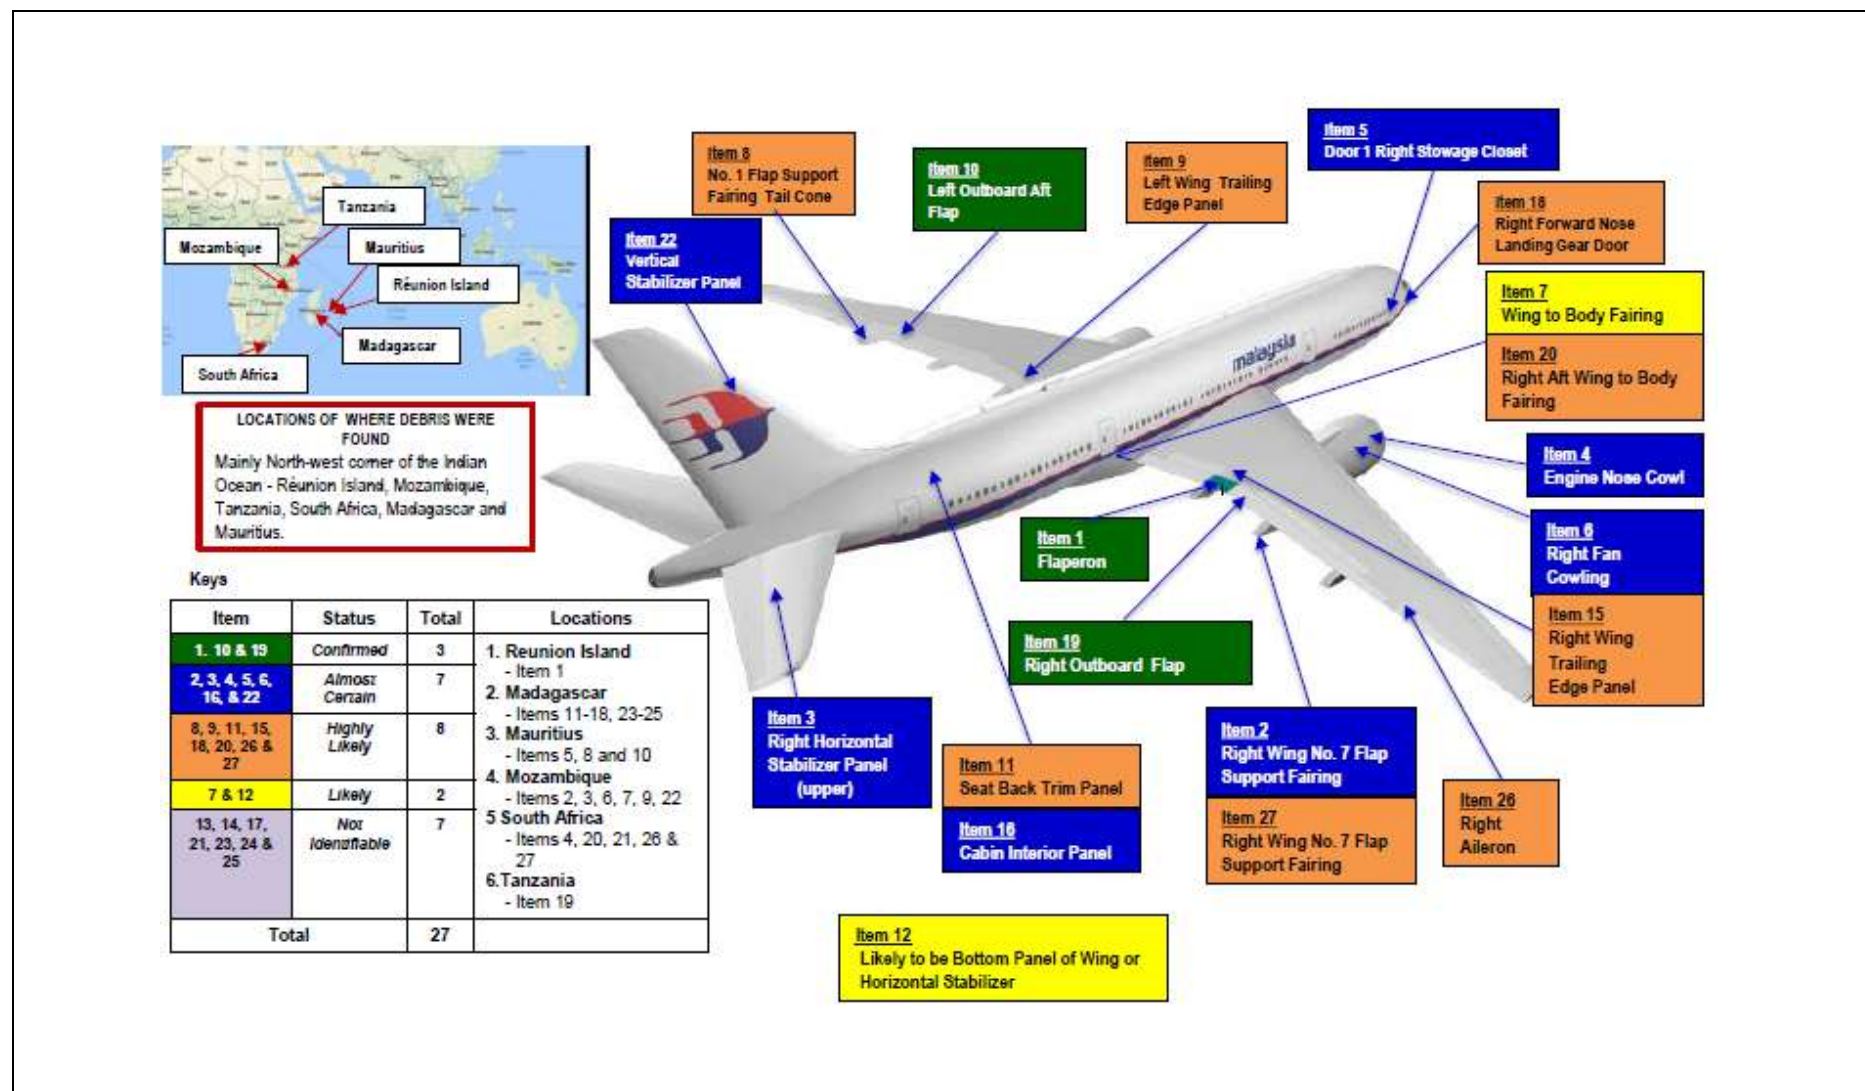
Figure 2.6A - Location of Parts and Debris Found with respect to Aircraft

*Figure 2.6A* (below) shows the locations of the debris with respect to the aircraft.

Item 4 (part of the Engine Nose Cowl) is depicted to be from the right engine. There were no significant differentiators on the cowl segment to assist in determining whether the item of debris was from the left or right side of the aircraft, or the inboard or outboard side the cowl. Similarly, although Item 6 (part of the RH fan cowl) is depicted to be from the right engine in *Figure 2.6A*, there is a possibility that it could also be from the left engine. As for Item 7 - Wing body fairing - this too could be from either side of the aircraft.

Based on the identification of the parts and debris found, it shows that most of those parts and debris were from the right hand side of the aircraft.

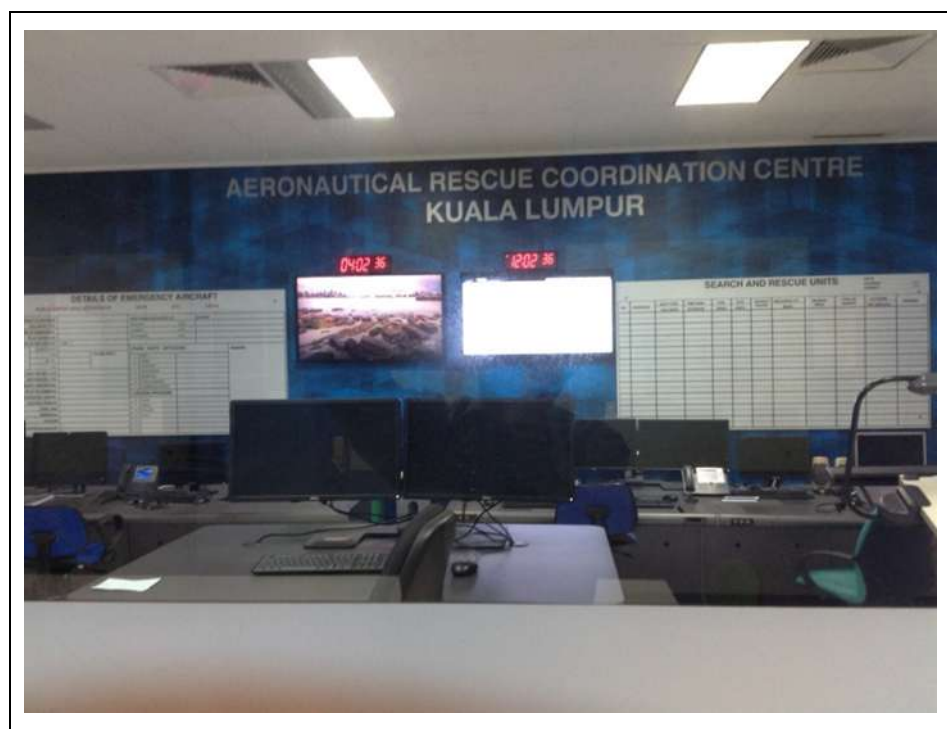
Figure 2.7A - Kuala Lumpur - Aeronautical Rescue Coordination Centre (ARCC)

On 08 March 2014 [MYT], MH370 operated within the “Delegated Airspace”. The radar position symbol dropped from the radar display at 1721:13 UTC [0121:13 MYT]. Though the KL ACC was responsible for the provision of Air Traffic Services, no alerting action was taken. At 2130 UTC [0530 MYT] the KL ATSC Duty Watch Supervisor directed the Search and Rescue Mission Coordinator (SARMC) to activate the ARCC (*Figure 2.7A* above and *Figure 2.7B* below). After the ARCC was activated, and due to a lack of details from the KL ATSC Duty Watch Supervisor, the SARMC only managed to disseminate the distress message at 2232 UTC [0632 MYT], an hour and two minutes later.

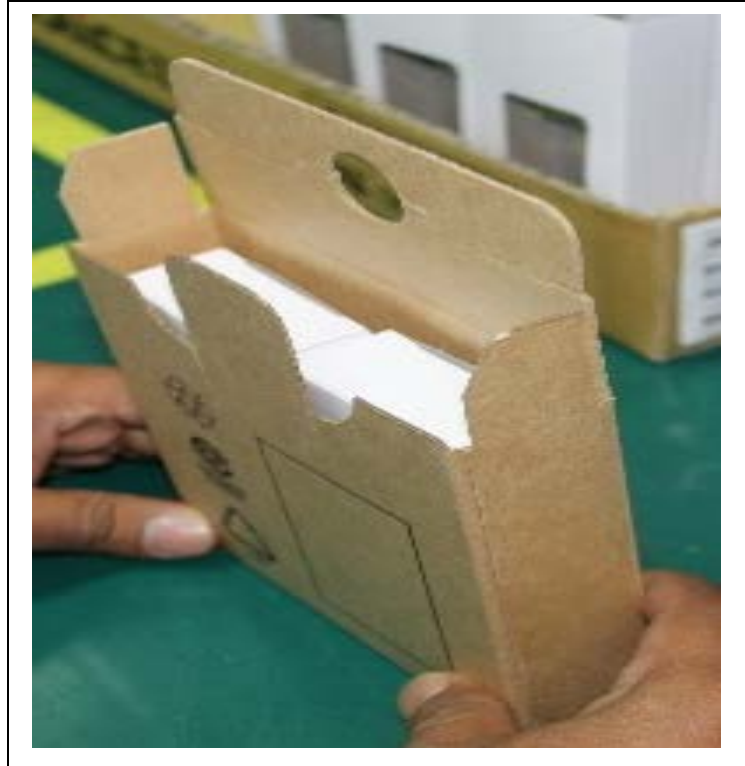
*Figure 2.8A - 2 Batteries in window white box and placed in a brown box*

The tests were carried out with batteries (window white box in brown box (*Figure 2.8A*, [below]) dropped at a height of 120.92 cm (48 inches) on to a wooden platform. It was found that the batteries had no observable physical damage and functioned normally.
